CABIN HAZARDS FROM A LARGE EXTERNAL FUEL FIRE ADJACENT TO AN AIRCRAFT FUSELAGE

Louis J. Brown, Jr.

AUGUST 1979

FINAL REPORT

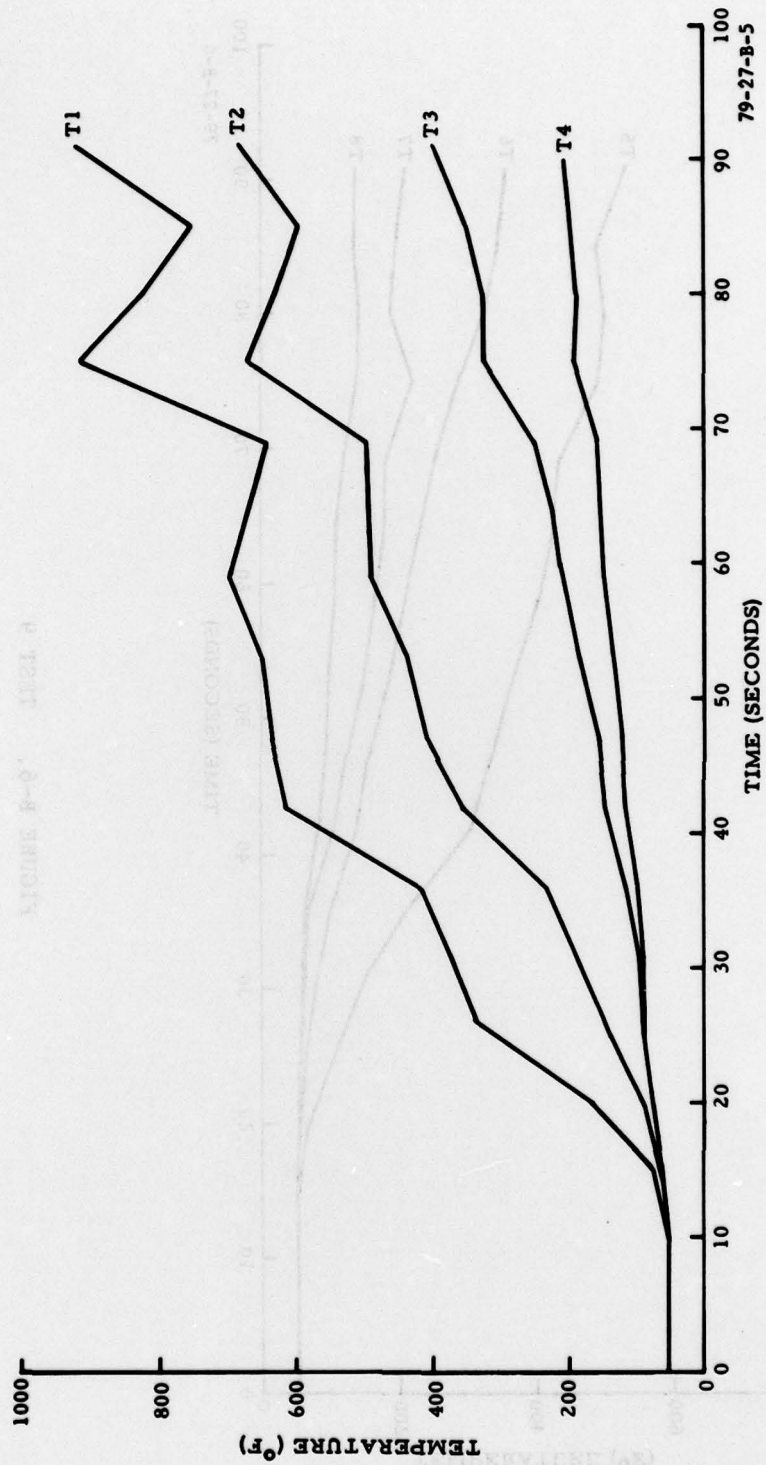
APPENDIX B
TEMPERATURE STRATIFICATION PLOTS

Appendix B contains temperature stratification data during tests 3, 4, 9, 10, 13, and 14 for both thermocouple trees. These plots clearly show the variation in the distribution of heat between the cabin floor and ceiling from test to test.
